**IMPACT RESISTANCE OF  
COMPOSITE FAN BLADES**

**E. J. PREMONT  
K. R. STUBENRAUCH**

**PRATT & WHITNEY AIRCRAFT  
DIVISION OF UNITED AIRCRAFT CORPORATION**

**CONTRACT NAS3-16763**

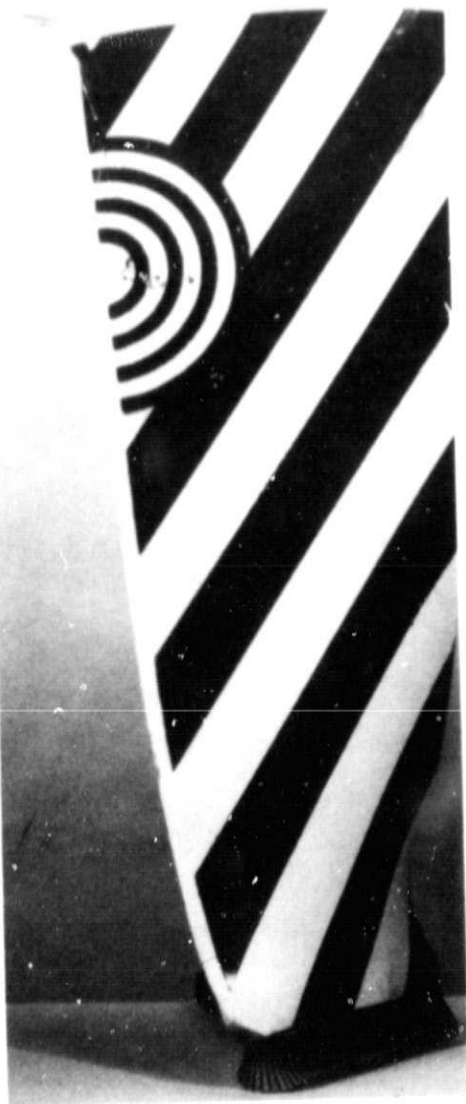
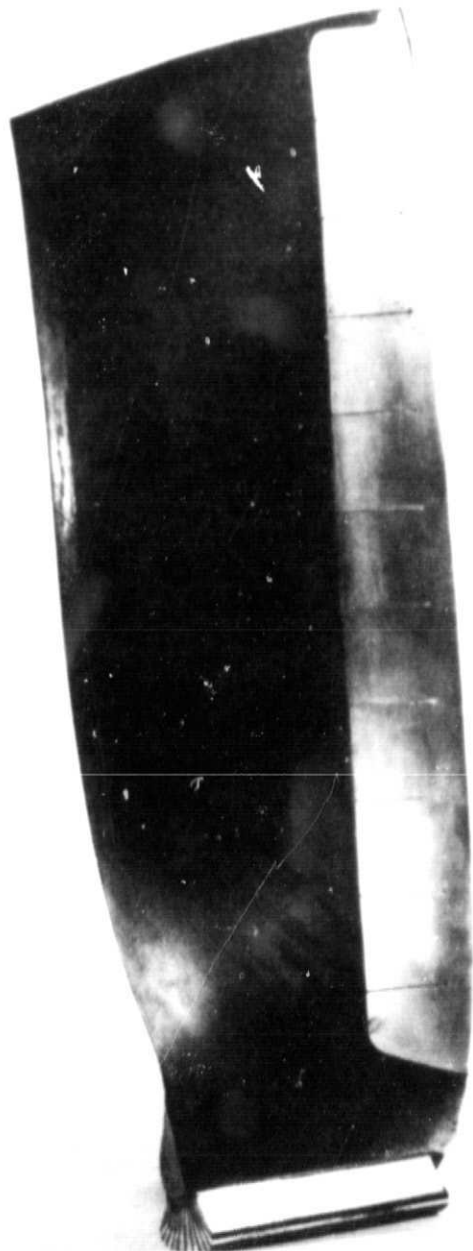
Blade C-5 and B-5 were impacted with 75g (2.6 oz) and 80 g (2.9 oz) starlings, respectively. The 40g (1.4 oz) slice taken by C-5 and the 45g (1.6 oz) slice cut by B-5 caused only slight damage in each case. The damage which occurred seems to be related to blade fabrication problems. Both blades are pictured in Figures 50 and 51 respectively.

Figure 51 Boron/Epoxy Blade B-5 Following Impact with 80g Starling

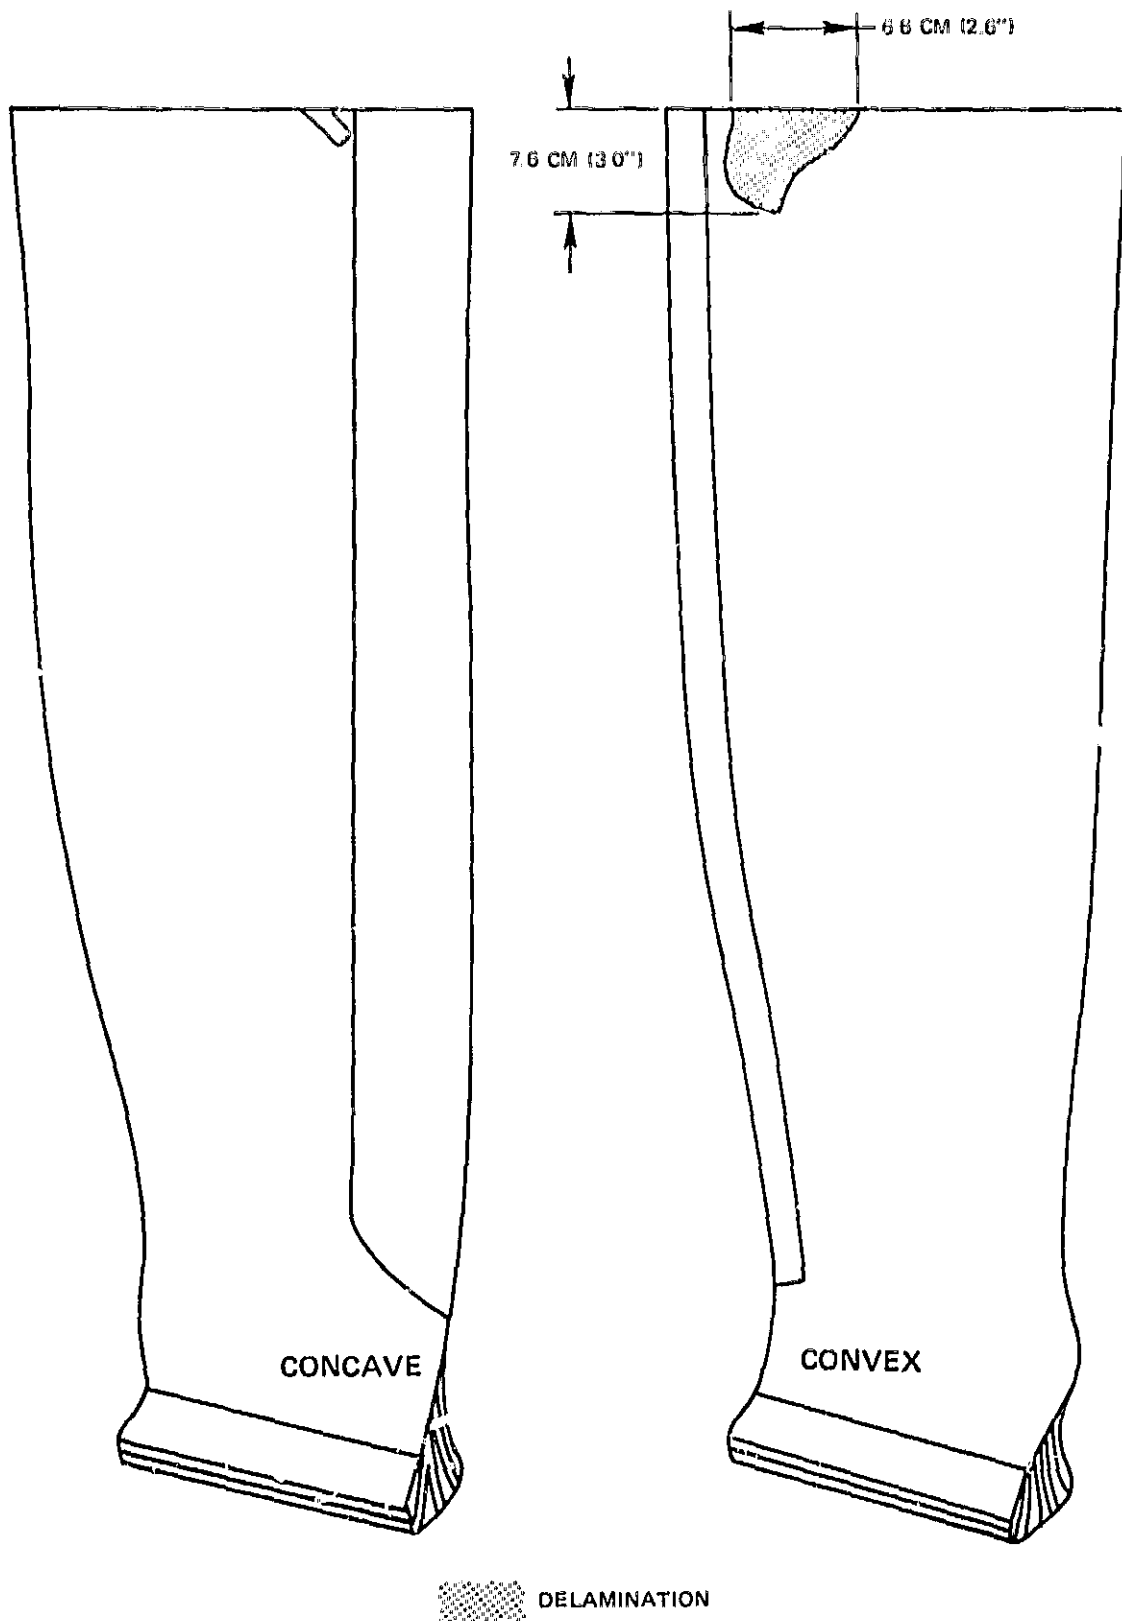
The visually delaminated area of C-5 shown in Figure 52, which also corresponds to post-test ultrasonic indications, is in a location where a pre-test ultrasonic indication was present. The starling impact caused this area of delamination to grow. If the blade had been well consolidated in this area, possibly no damage would have occurred from the impact.

Figure 52 Visual Damage to Graphite/Epoxy Blade C-5 Following Impact with Starling

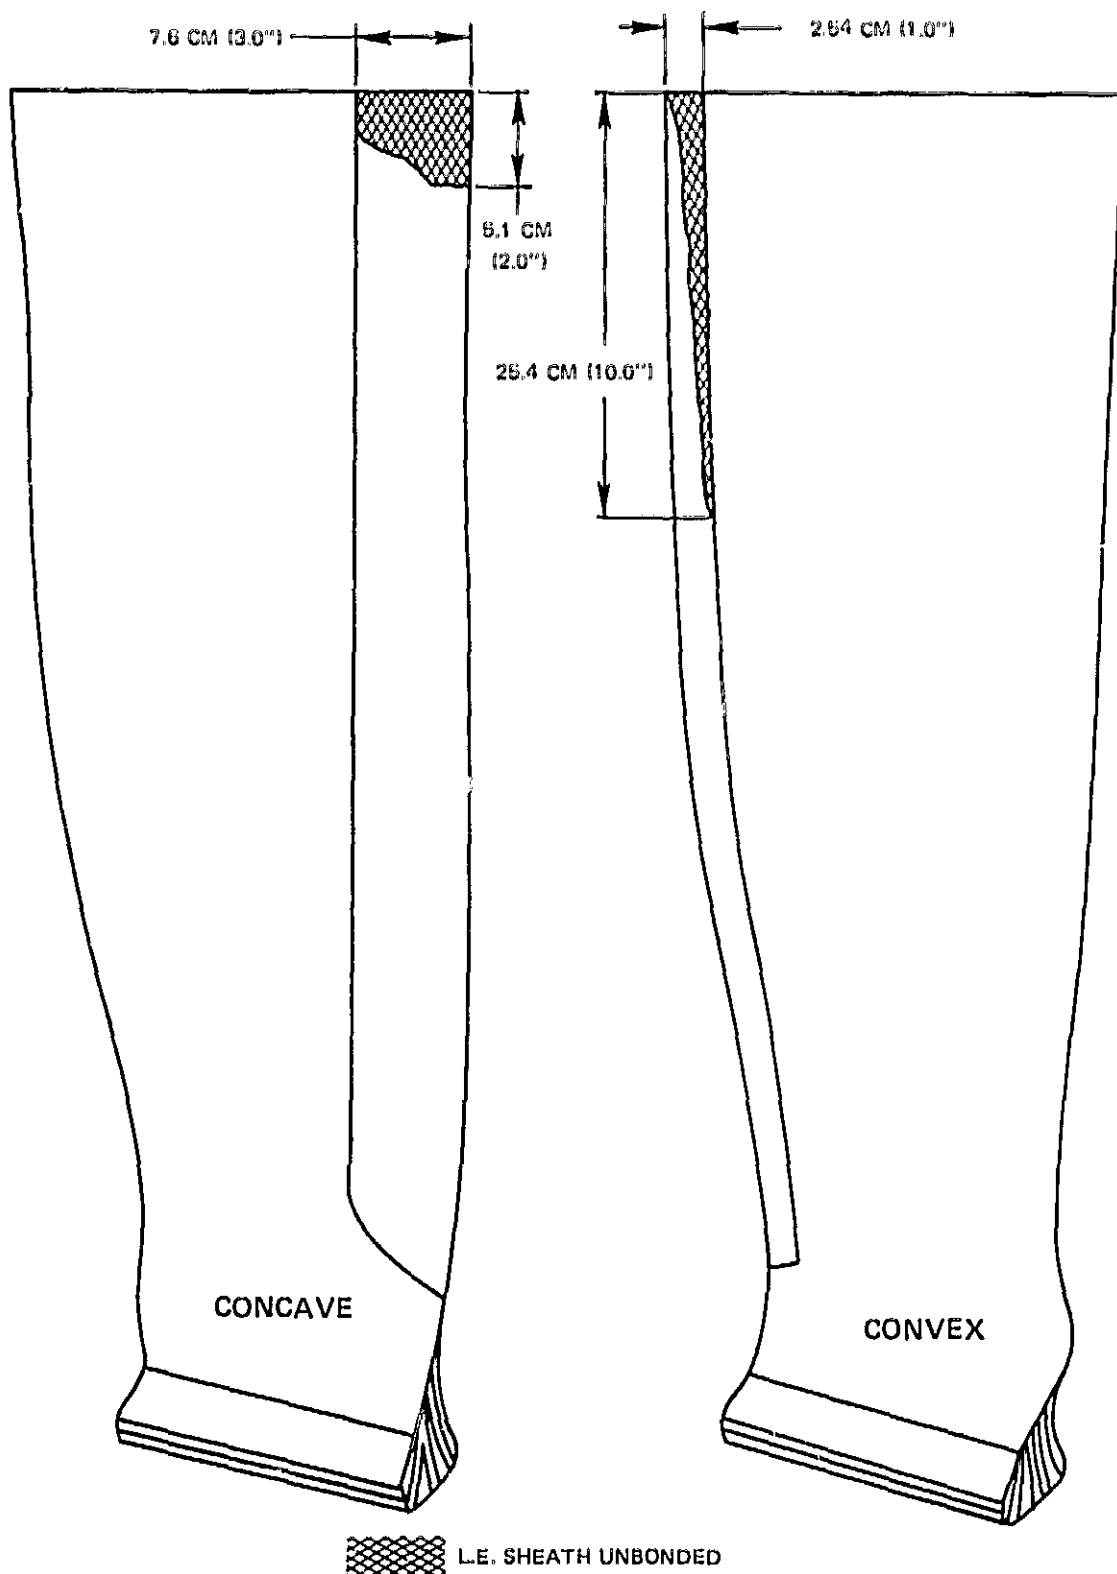
Only a small amount of leading-edge sheath unbonding, as shown in Figure 53, resulted from B-5 starling impact. Better bonding of the sheath to the blade could perhaps prevent such damage. No post-test ultrasonic indications were found on this blade.

Figure 53 Visual Damage to Boron/Epoxy Blade B-5 Following Impact with Starling

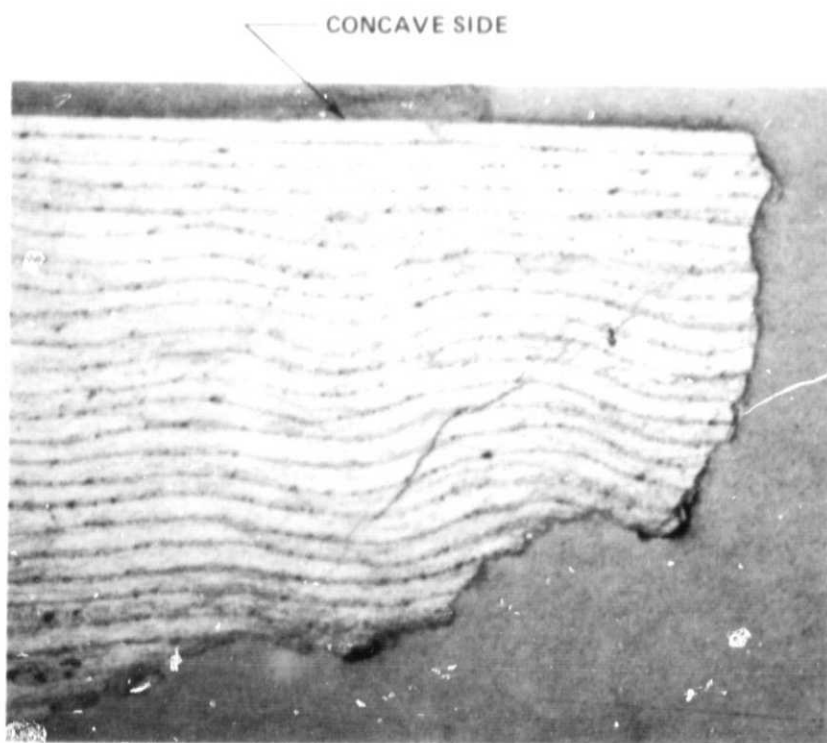
Graphite/epoxy blade C-3 was sectioned in the area of the impact damage for metallographic study. Two chordwise sections were examined, as illustrated in Figure 54. Section 1 revealed a shear crack of approximately .41 cm (.16 in) length angled at 40° from the concave blade surface as shown in Figure 55. Section 2, pictured in Figure 56, revealed five interlaminar separations which propagated for a length of .10 cm (.04 in) to .66 cm (.26 in) in the chordwise direction. No internal composite damage was found further away from the broken area of the blade.

Figure 55 Photo-micrograph of Area 1, (Figure 54), of Graphite/Epoxy Blade C-3 Showing Shear Crack (15X)

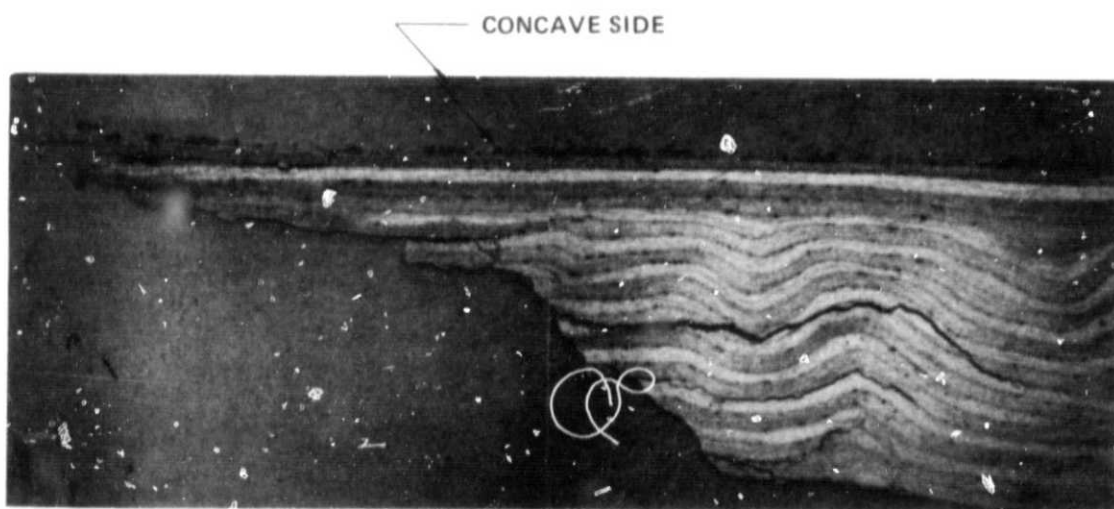
Figure 56 Photo-micrograph of Area 2, (Figure 54), Graphite/E<sub>f</sub> Blade C-3 Showing Interlaminar Separations (13X)
